The Performance of House Foundations in the Canterbury Earthquakes

Master of Engineering in Civil Engineering

Duncan Henderson

August, 2013

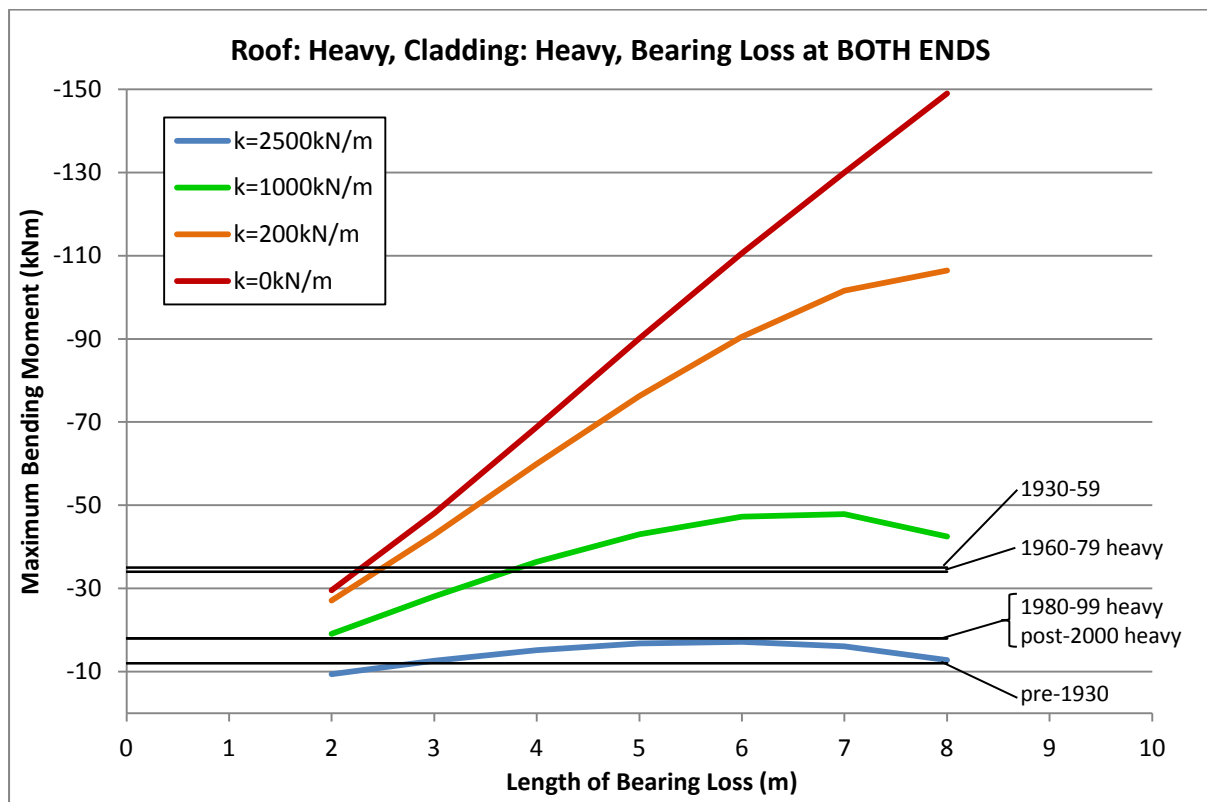
For heavy claddings the results were very similar to bearing loss in the centre. As can be seen in Figure 6.12 for heavy roofs, all section yield capacities were exceeded by more than 4m of 80% bearing loss, which is only increased to 4.5m for light roofs (Appendix S.3). Due to the negative moment demands, the 1980-99 and post-2000 sections performed significantly worse than for bearing loss in the centre, due to their lower yield capacities for reverse loading. These two sections can only just resist 50% bearing loss, and will yield under 2-2.5m of 80% bearing loss, depending whether the roof is heavy or light. The pre-1930 section performs similarly to bearing loss in the centre, hovering around the 50% bearing loss demands.

Figure 6.12. Moment demands for heavy roof and cladding for different levels and lengths of bearing loss at both ends. Yield capacities of the corresponding perimeter sections are also shown.

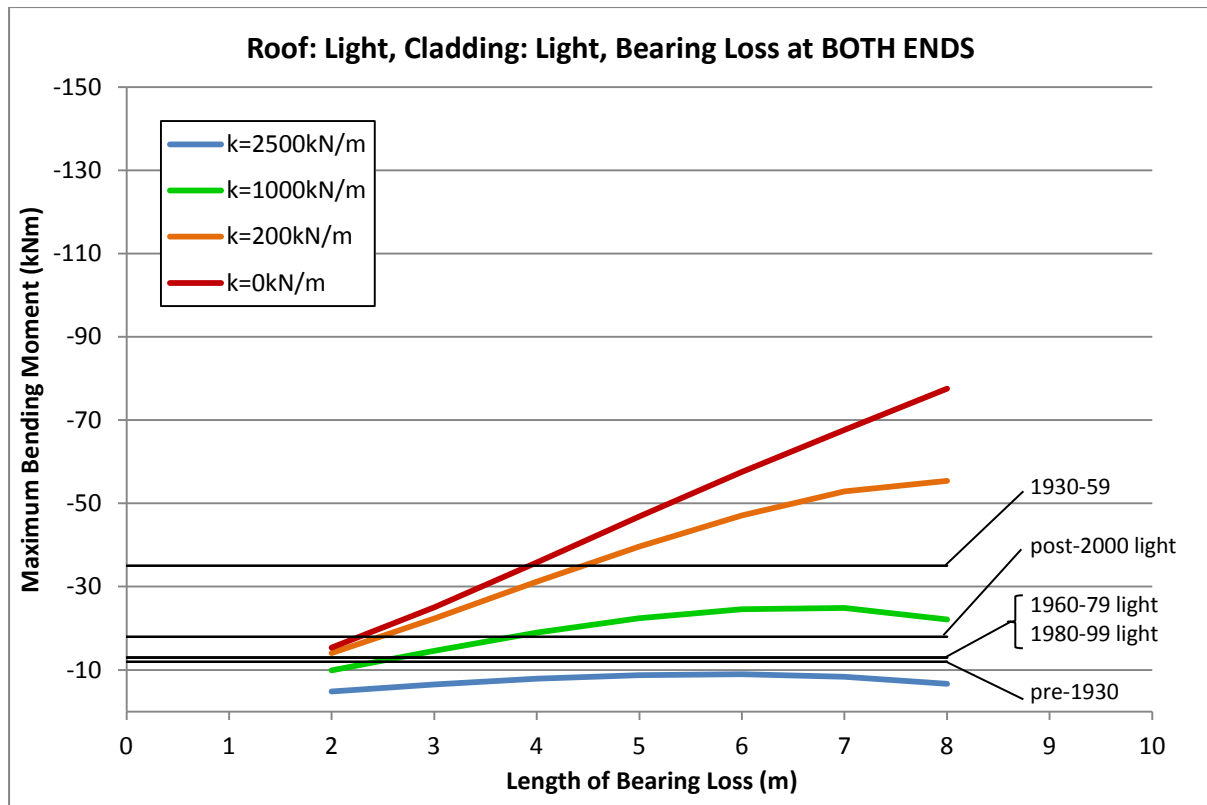
For light claddings, shown in Figure 6.13, the 1930-59 section will yield with more than 3.5-4.5m of 96% bearing loss for heavy or light roofs. The post-2000 section again performs better with light claddings as its reverse strength is not reduced, allowing it to resist up to 4m of 80% bearing loss for light roofs before yielding. This is reduced to 3m for heavy roofs. The 1960-79 section performs worse for light claddings, due to its reduced strength, making it the same as the 1980-99 and pre-1930 sections. These three sections will all yield with just 2.5m of 80% bearing loss for light roofs, which reduces to 2m for heavy roofs.

Figure 6.13. Moment demands for light roof and cladding for different levels and lengths of bearing loss at both ends. Yield capacities of the corresponding perimeter sections are also shown.

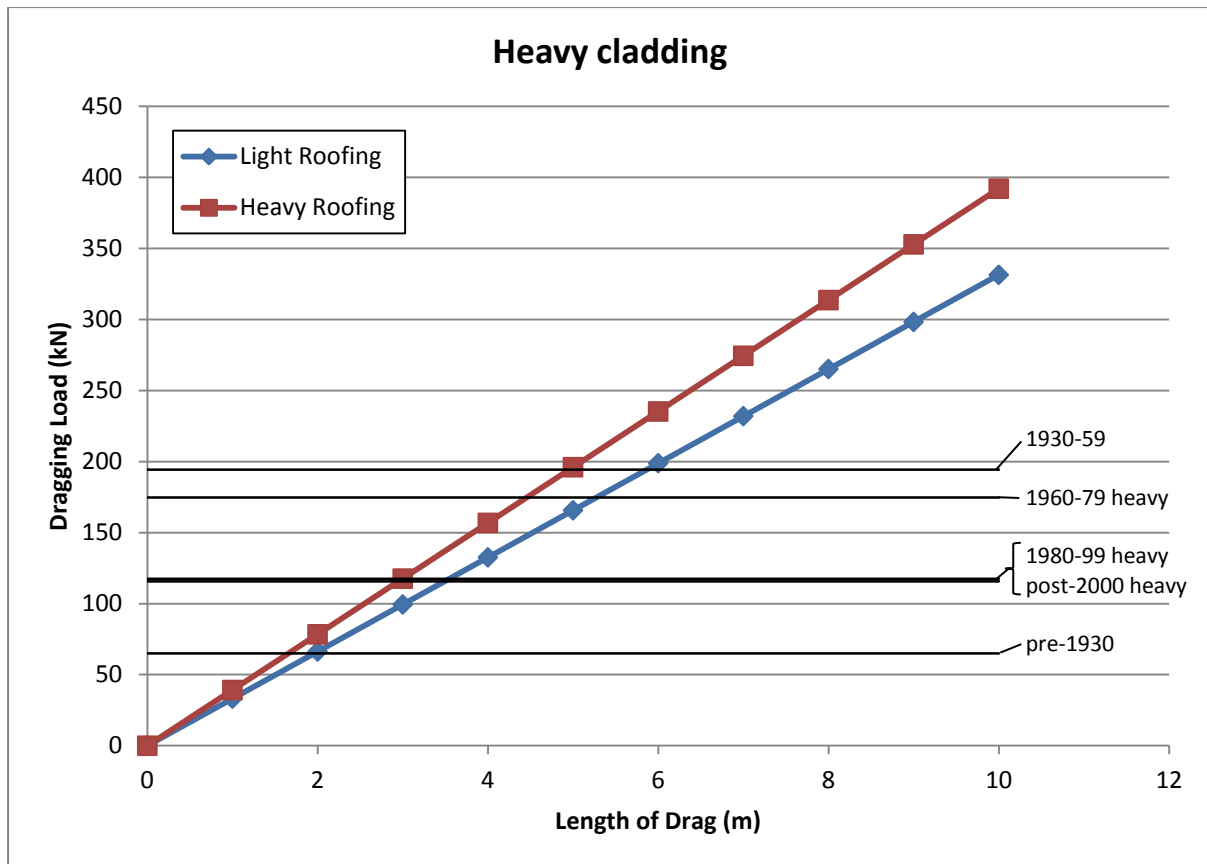
Figure 6.14. Axial tension loads caused by dragging along foundation over different lengths for heavy cladding, showing results for light and heavy roofing, with axial capacities of corresponding sections.

Heavy cladding, shown in Figure 6.14, produced demands 130kN higher than light cladding (Figure 6.15) over 10m of drag, with the roof cladding changing results by 60kN in each case, again at 10m of drag. This only caused a 15% change between light and heavy roofs for heavy cladding, but caused a 23% change for light cladding.

For heavy cladding in Figure 6.14, the pre-1930 section fails after 1.5-2m of drag. For the 1980-99 and post-2000 sections this increases to 3-3.5m of drag, and the 1930-59 and 1960-79 sections, which have a similar performance, can resist between 4.5-6m of drag. For the 1930-59 section, which has the highest axial capacity, having a heavy roof with heavy cladding means the section would fail at 5m, 1m earlier than for a light roof and heavy cladding, where failure occurs with 6m of drag, at a load of 200kN.

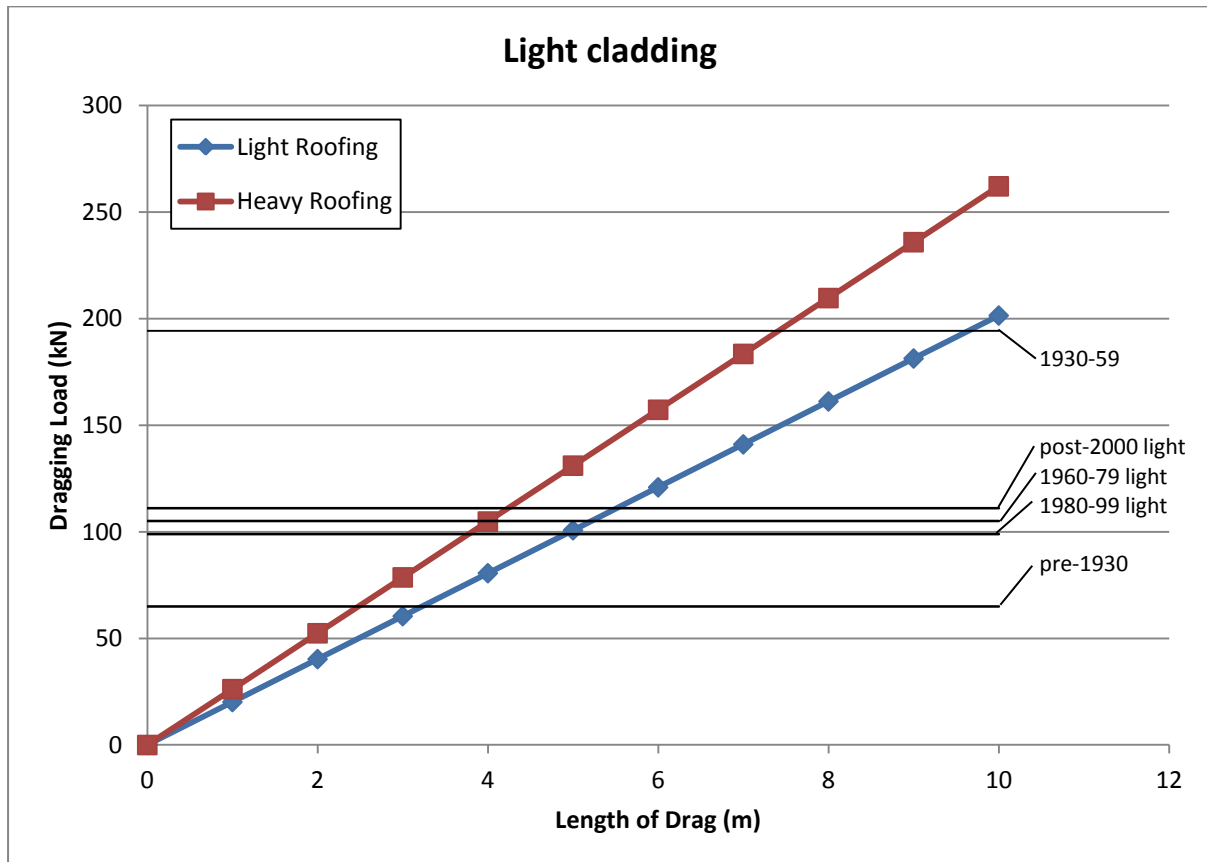
Figure 6.15. Axial tension loads caused by dragging along foundation over different lengths for light cladding, showing results for light and heavy roofing, with axial capacities of corresponding sections.

For light cladding, shown in Figure 6.15, the pre-1930 and 1930-59 sections performed better, as their design strength is not reduced based on cladding type. However, these two sections are still expected to fail under 4-5m and 7.5-9.5m of drag respectively. The newest three sections all have very similar capacity, due to reduced strengths for light claddings for all three. They are all expected to fail between 4-5.5m of drag depending on the section and roof cladding. This corresponds to a slight improvement for 1980-99 and post-2000 sections from the heavy cladding case, as the demands under light cladding have reduced more than their axial capacities. The 1960-79 section performance is reduced, as its strength is reduced the most between heavy and light claddings. Heavy roof cladding has a larger effect when the wall cladding is light, causing the 1930-59 section to fail 2m earlier at 200kN than with light roof cladding.

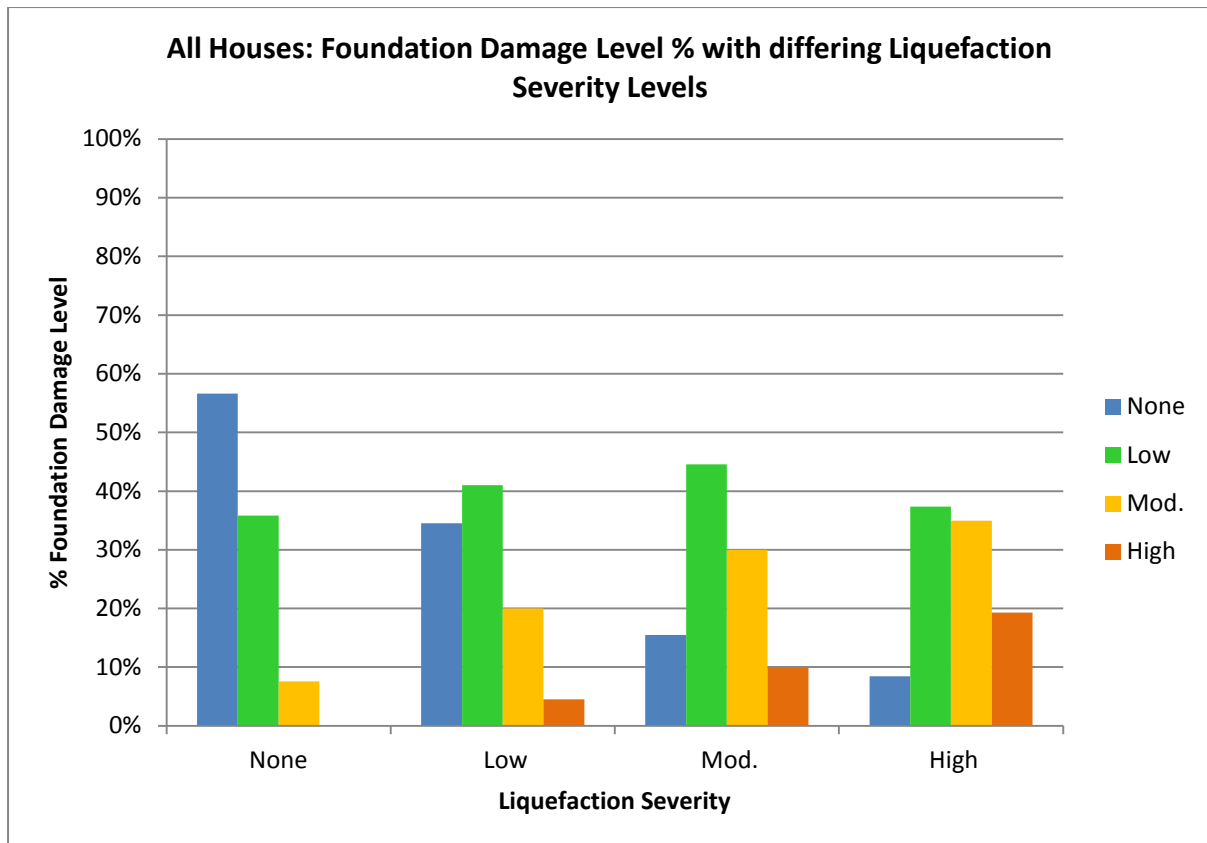
Figure A. 1. Distribution of foundation damage level in percentage for differing levels of liquefaction severity for all houses.

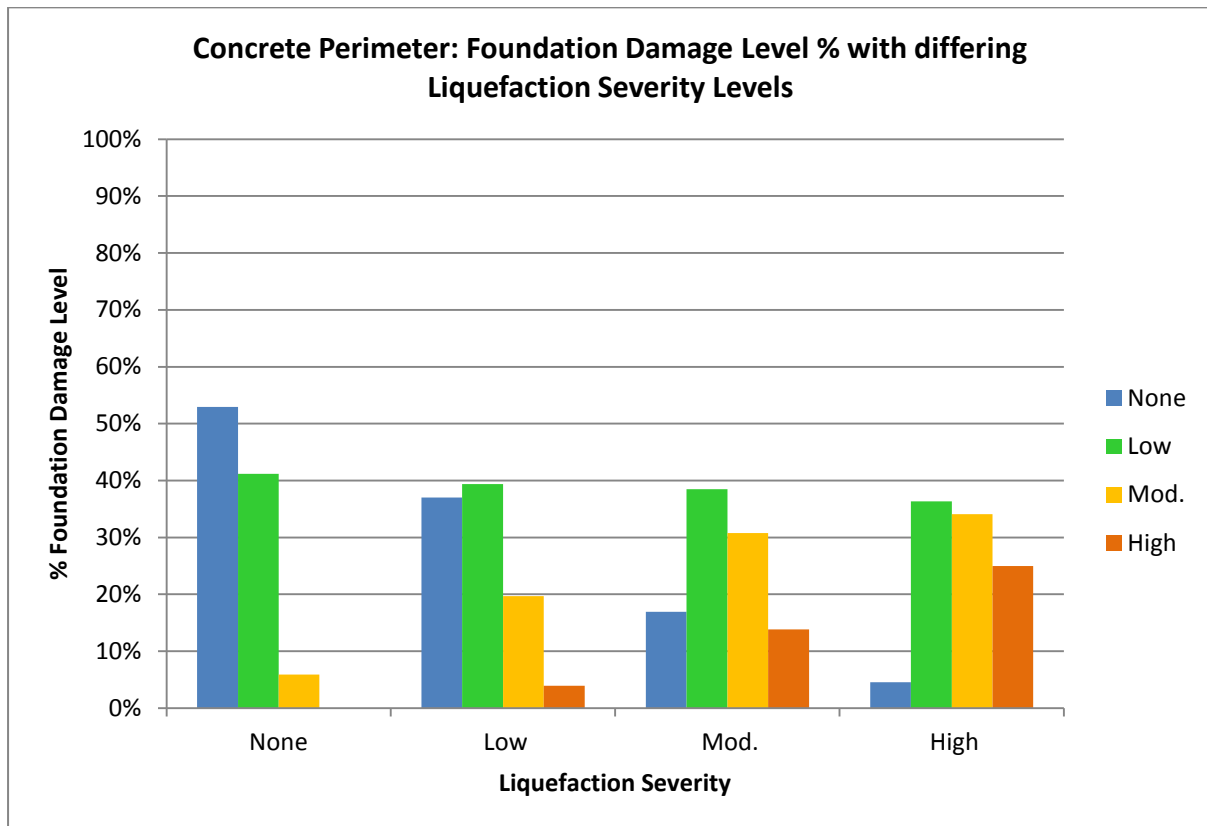
Figure A. 3. Distribution of foundation damage level in percentage for differing levels of liquefaction severity for concrete perimeter foundations.

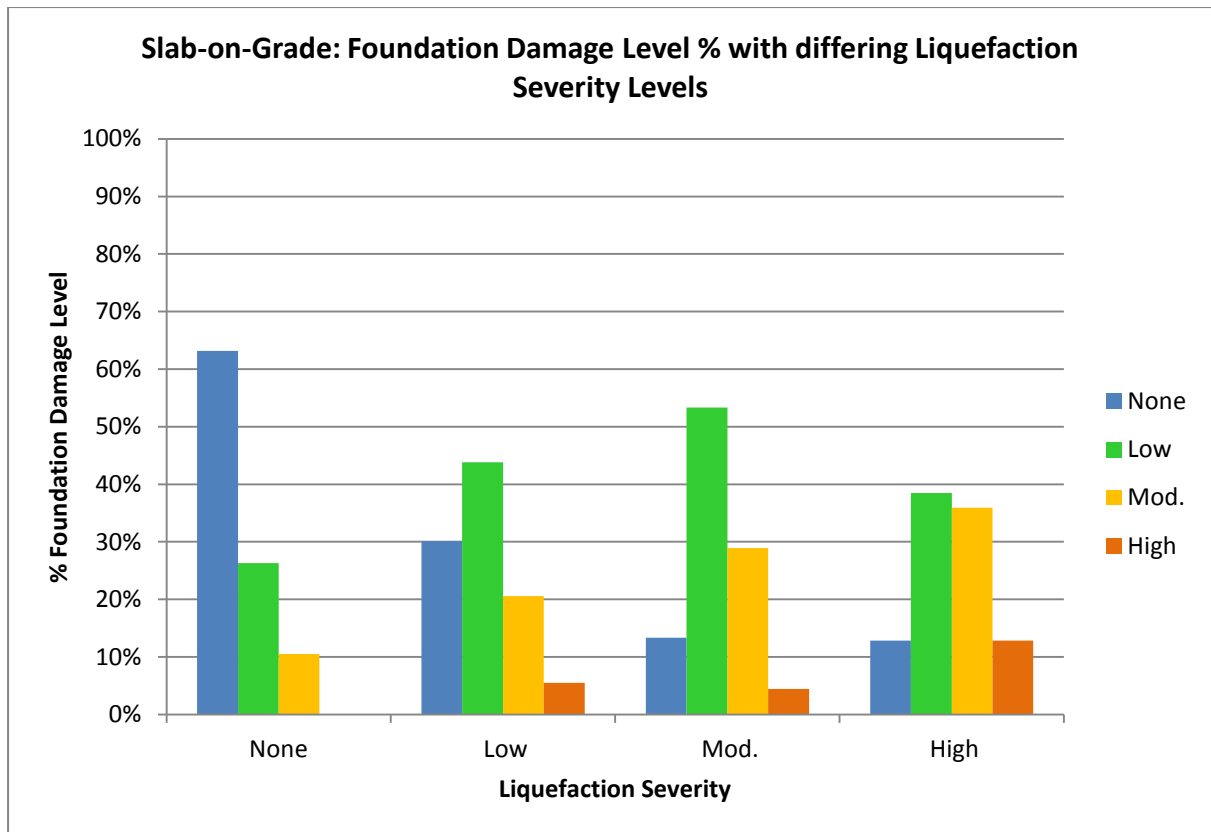
Figure A. 5. Distribution of foundation damage level in percentage for differing levels of liquefaction severity for slab-on-grade foundations.

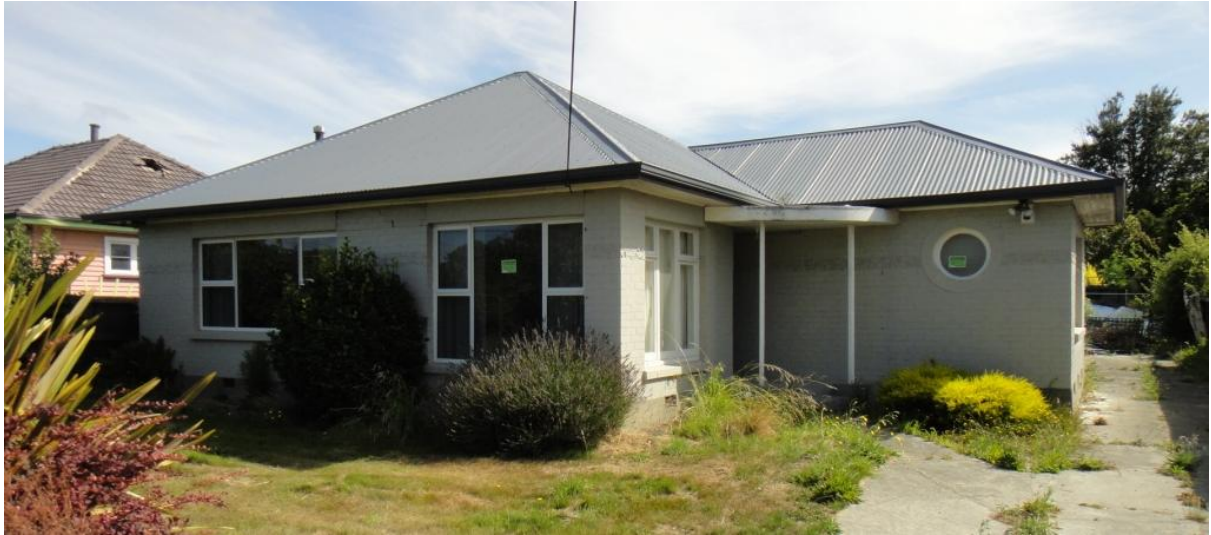
Figure 3. P1: Looking West at the East (roadside) front of the house.

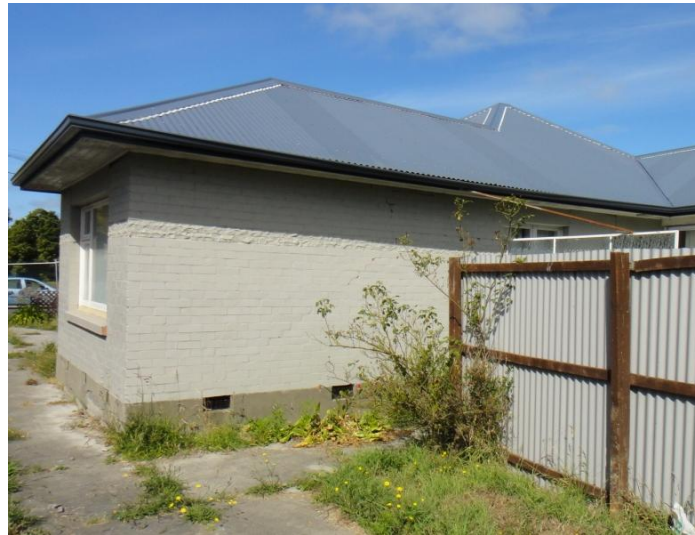
Figure 4. P2: Looking East at the Northwest corner of the house.

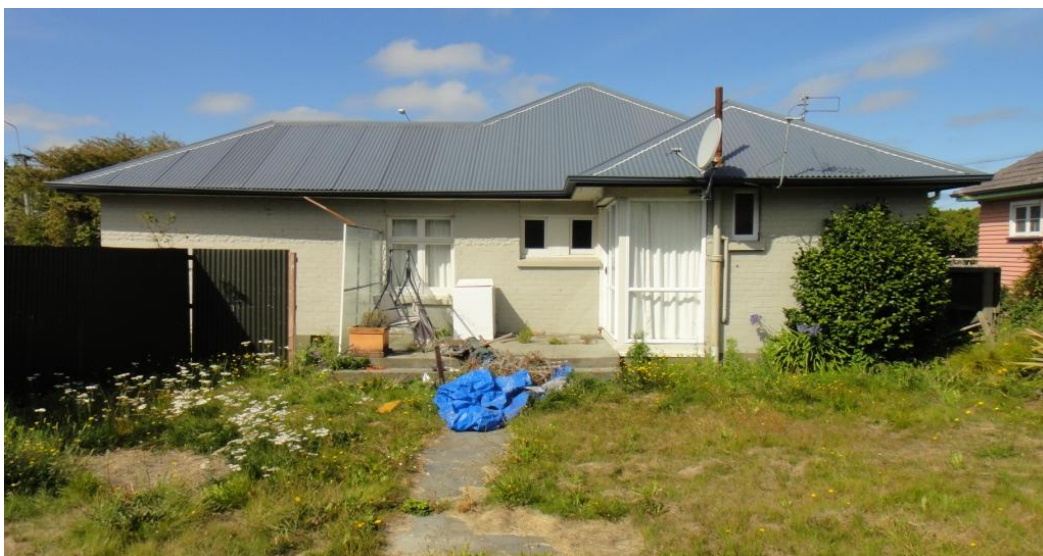
Figure 5. P3: Looking East at the West side of the house.

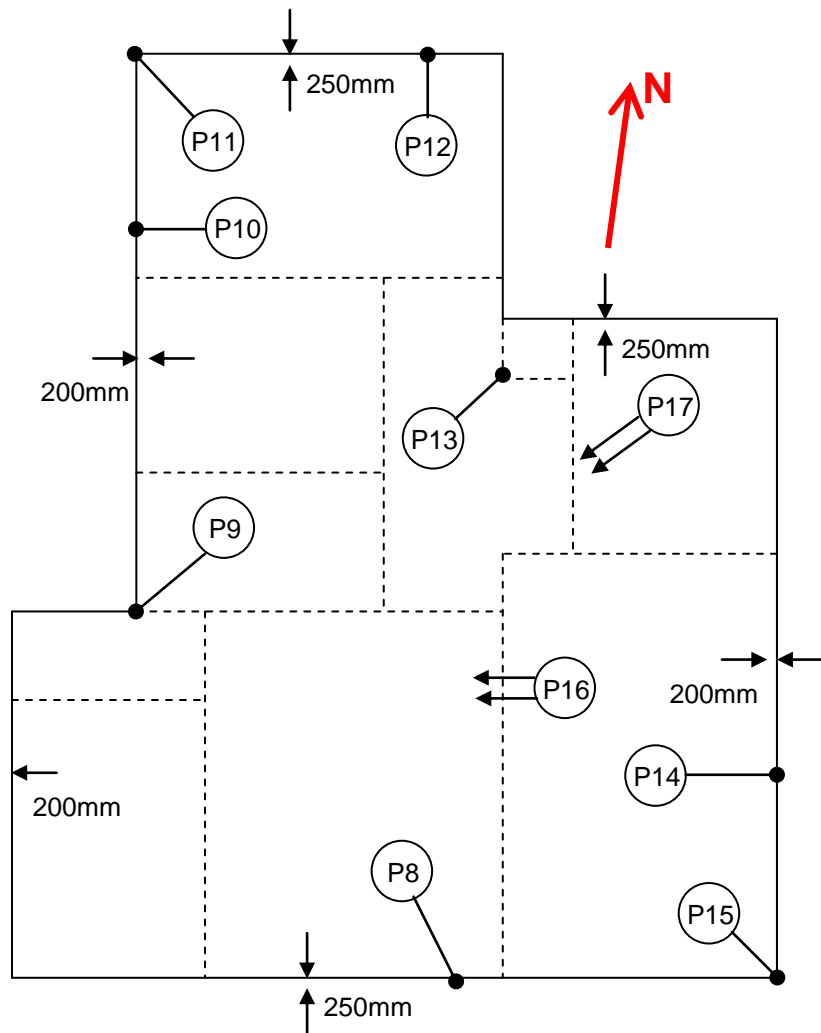
The perimeter is constructed with cast-in-place concrete. The aggregate is round stone, very uniformly graded between 10-20mm diameter. Large round stones of 200-300mm diameter have been used as fill throughout the perimeter of the house. The perimeter was quite weak around these large stones, and mostly broke up around them. The concrete mix was found to be dry in places, where gaps around aggregate were found (Figure 7). The perimeter extended about 500mm above the ground level, and 200-250mm into the ground, for a total height of 700-750mm. The widths were 200mm on N-S running walls and 250 on E-W running walls (Figure 6).

Figure 6. Floor plan showing general layout of house, with perimeter footing widths and locations of following photos.

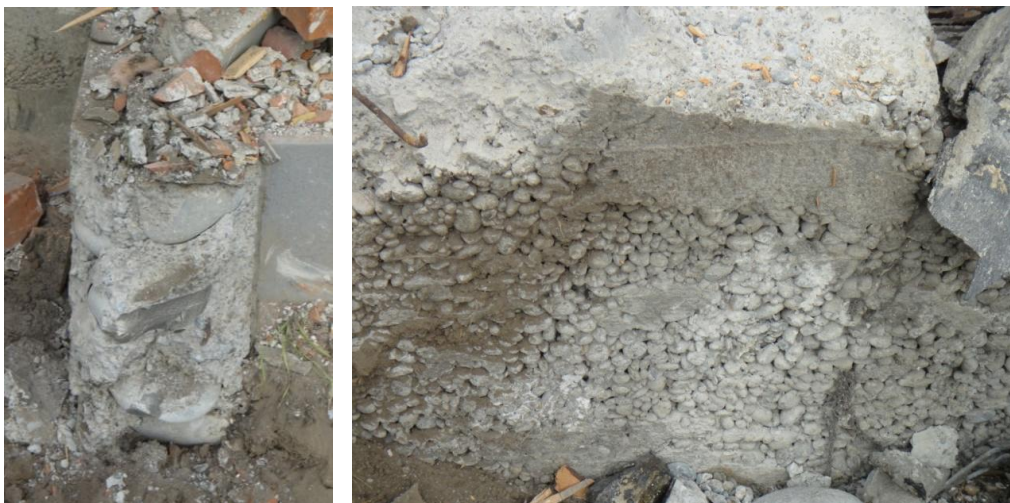
Figure 7. Foundation details, (right) perimeter, showing large stones in concrete and (left) round aggregate in perimeter.

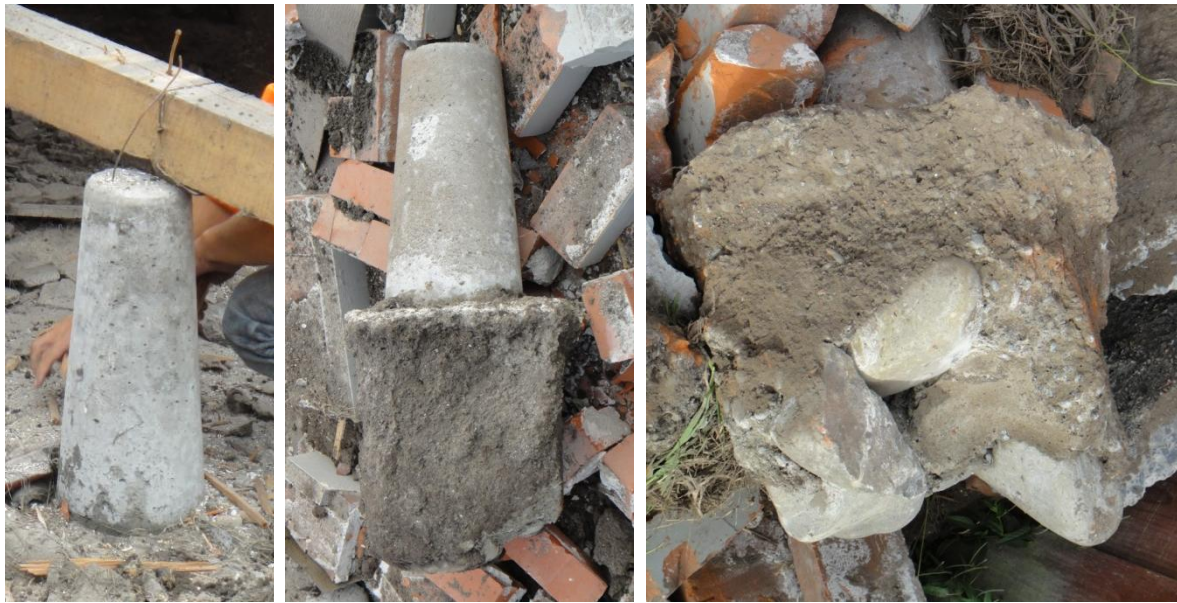
The piers were round pre-cast concrete with a top diameter of 150mm and bottom diameter of ~200mm. They were set in the ground by ~100mm, giving ~400mm above ground. The footings for these were 200-400mm deep and ~300mm square/round cast-in-place again using the large stones as fill (as for the perimeter). The floor bearers were attached to the tops of these with wire legs (Figure 8).

Figure 8. Pier details, (left) pier in ground, (centre) pier and footing, (right) large stones in footing.

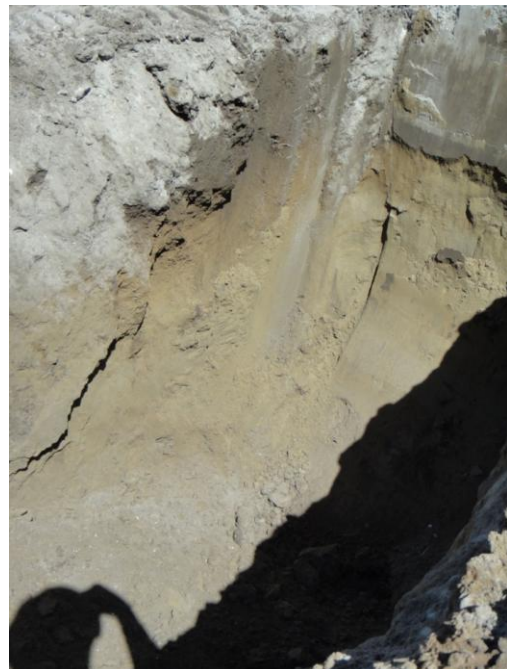
Under the foundations and floor, the ground was pure sand. While there was liquefaction ejecta on top of the ground, and also mixed into the top layer, this pure sand extended fully to at least 1.8m, without any sign of soil or other materials (Figure 9).

Figure 9. 1.8m test pit under house, showing sand throughout depth.

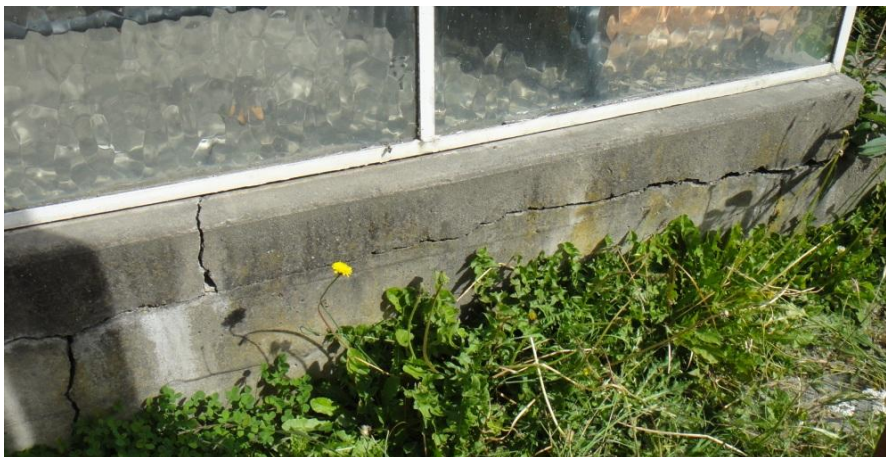
P4

The concrete deck on the West side of the house was tilting in different directions. It was separated from the perimeter foundation by ~10mm on its South side. There was a significant horizontal crack running the whole length on the N side right through, and a few minor cracks on top of the deck (Figure 10, P4).

Figure 10. P4: Cracking along concrete deck. P5: Damage to fence. P6: Heaving of pavement in driveway. P7: Some small amounts of sand ejecta left in back lawn.

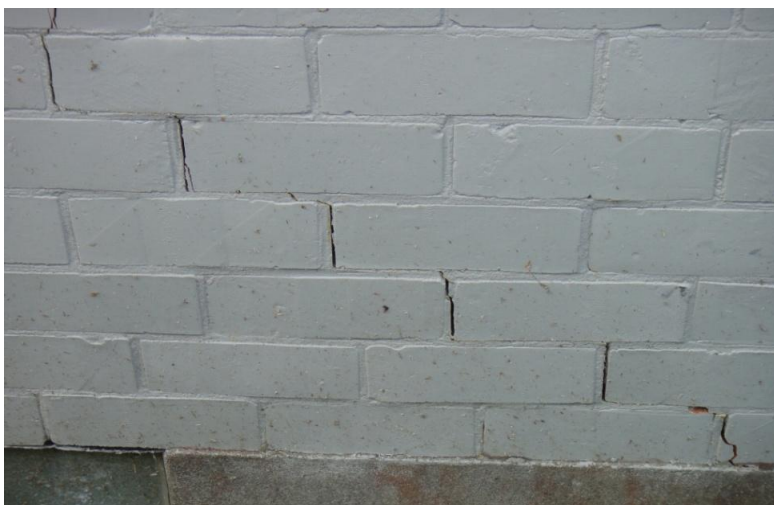
P8

There was significant structural damage over the whole building. The exterior cladding had numerous diagonal cracks in the brickwork, from 1-10mm, with a smaller number of horizontal and vertical cracks too (Figure 11 and Figure 12). The majority of these cracks caused horizontal separation between the bricks, suggesting foundation movement had caused bits of the house to tilt differentially and pull away from each other. There were two significant cracks on either side of the Northwest corner of the house. The one on the West wall was diagonal and extended the full height of the wall, 0mm in width at the bottom (close to the corner) to 10mm of horizontal separation at the top away from the corner (Figure 12, P10). On the North wall, another diagonal crack started with 0mm at the bottom at the corner, and opened to 10mm horizontal separation at the bottom window corner (Figure 12, P11). This was then continued as a 10-15mm horizontal separation between the window jam and bricks at the opposite (top) corner of the window (Figure 12, P12). This suggests that this whole corner of the house is separating out away from the rest of the house as the rest of the house tilts away from it.

Figure 11. P8: Diagonal crack in brickwork showing horizontal separation of 5mm. P9: Separation between door frame and brick cladding.

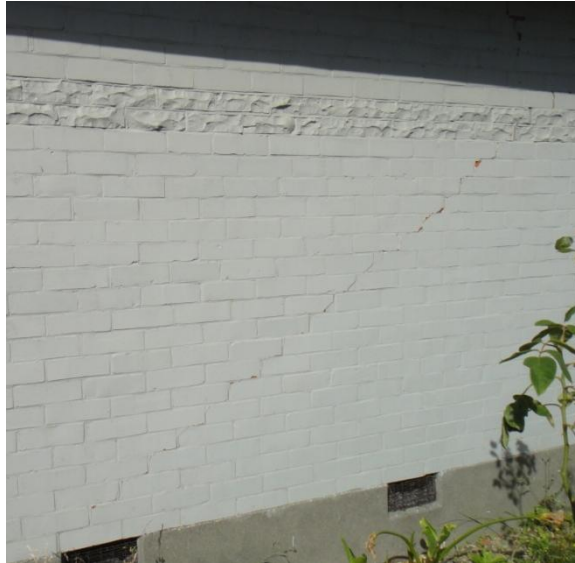
P10

Figure 12. P10: Diagonal crack 0-10mm horizontal separation from bottom of wall to top. P11: Diagonal crack causing 10mm horizontal separation and (P12) 15mm separation above window. P13: Cracking down front door frame. P14: Push out of wall/in of top bricks by 10-30mm.

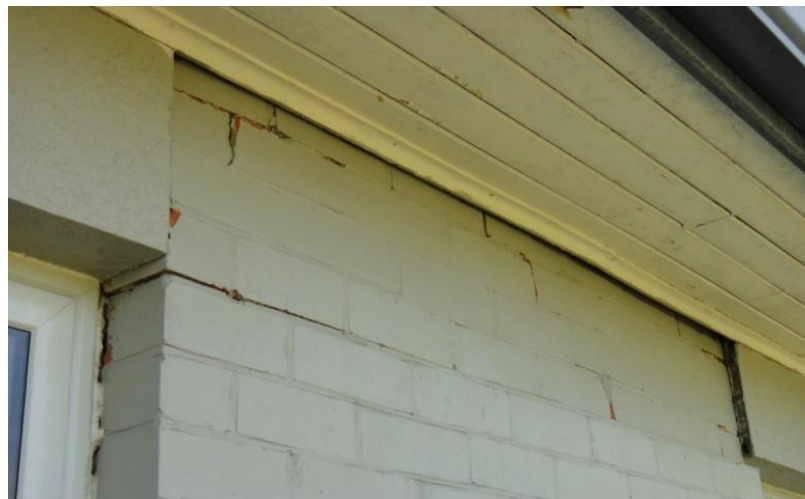
P14

Another significant area of damage was in the middle of the East wall. Here, the top four layers of bricks between two windows were pushed back into the house by up to 30mm. This may have been caused by the whole rest of the wall pushing out, or by shaking damage dislodging this section of bricks (Figure 12, P14).

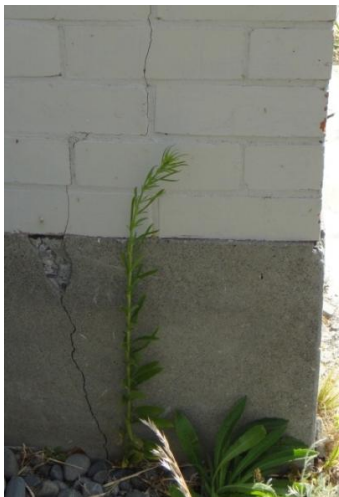
P15

There was significant damage to the foundation throughout the house. Damage to the perimeter however was not high. There were a total of 5 cracks around the perimeter, all of them 1-2mm wide (Figure 13, P15).

Figure 13. P15: Minor cracking in perimeter. P16: Large sand boils under foundation. P17: Looking SW over foundation showing extensive sand ejecta.

The concrete perimeter suffered only minor cracking in five locations around the perimeter, despite the large settlement and the weak construction of the perimeter, with no reinforcing, round aggregate and large stones for fill. This is due to the relatively uniform nature (around the perimeter) of the settlement, and possibly that the whole building was built on uniform sandy material, which provided little resistance to the settlement of the house during liquefaction.

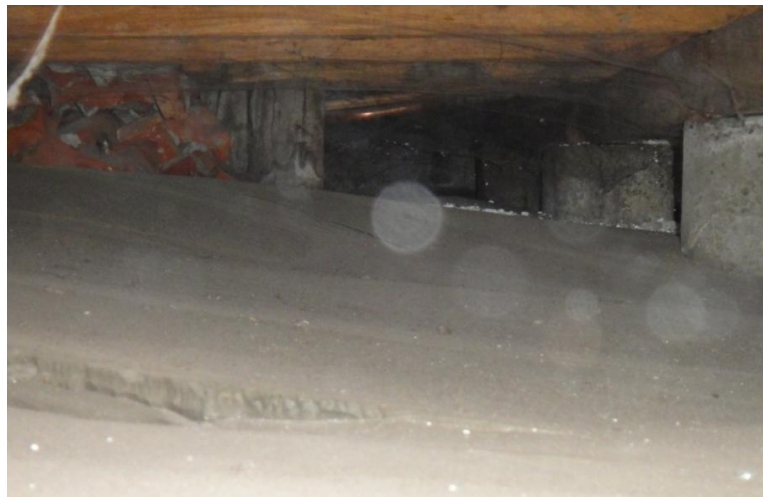
P16

However, the floor was very severely tilted. From the high point at the North corner of the East wall, there was 150mm total differential settlement to the Southwest corner. Although sloping of the floor was relatively consistent in this direction (to the Southwest), there were some variations in slope angles that showed room humping was present. There was one area in the kitchen where humping could be felt underfoot, and other more minor areas were identified through the floor slope angles. When the floor was lifted, extensive liquefaction was discovered under the floor covering the Southwest half of the house, along an approximate NW-SE line along the middle of the plan area. This explains the high level of tilt, and the floor humping present.

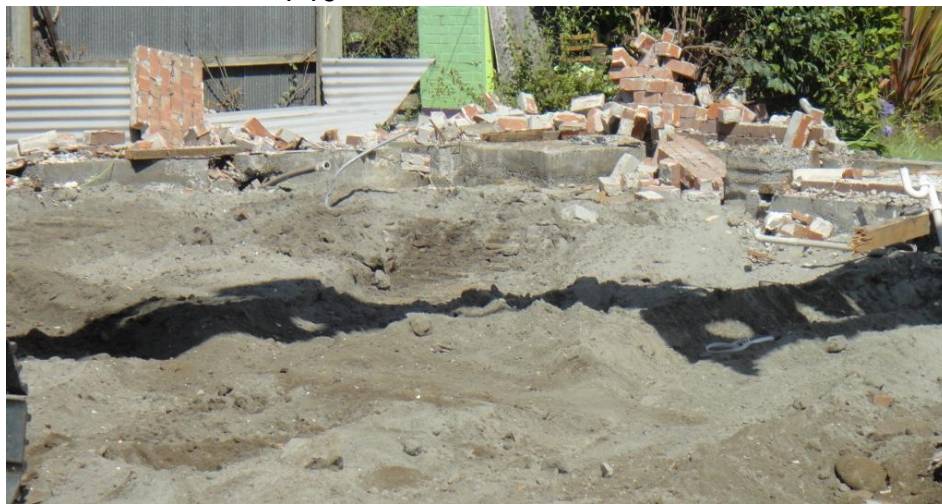
P17

The building had an overall differential settlement of 150mm to the Southwest with a maximum slope angle of 1.3° to the West. The house tilting was quite uniform overall, but there was some local room humping, in the Southwest rooms and the kitchen and in the North bedroom being the main areas. Extensive sand ejecta from liquefaction was found under half the house, and under all areas that suffered local humping (Figure 13). The sand ejecta was located under the Southwest half of the house, and was found to be consistent throughout the first 2m of a test pit that was dug. This is assumed to be the reason for the house tilting to the Southwest, as that is where the most severe liquefaction occurred.

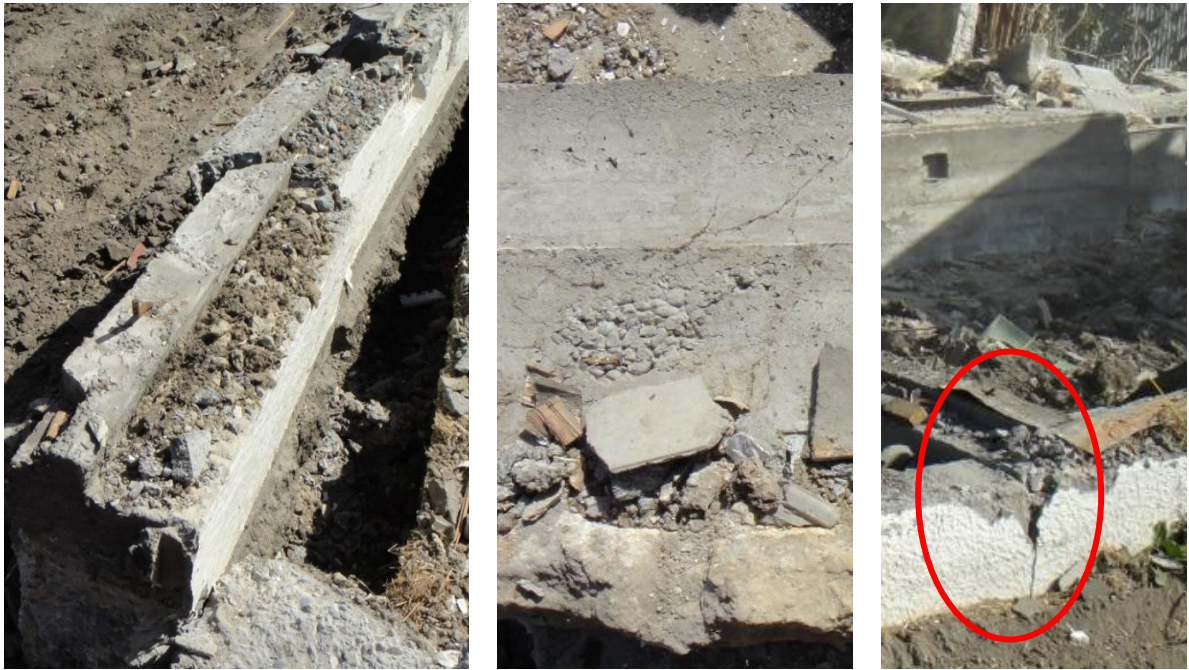
There was no physical connection between the original and extended perimeter walls, they simply sat beside each other. Both perimeter types came out of the ground quite easily, as they were not very deep, though took some breaking up. There were areas on both perimeters where there was no mix around the aggregate, and there were just stones touching each other (Figure 7).

Figure 7. Perimeter details, (left) main perimeter out of ground, (centre) dry area of concrete, (right) no connection between new and old perimeter.

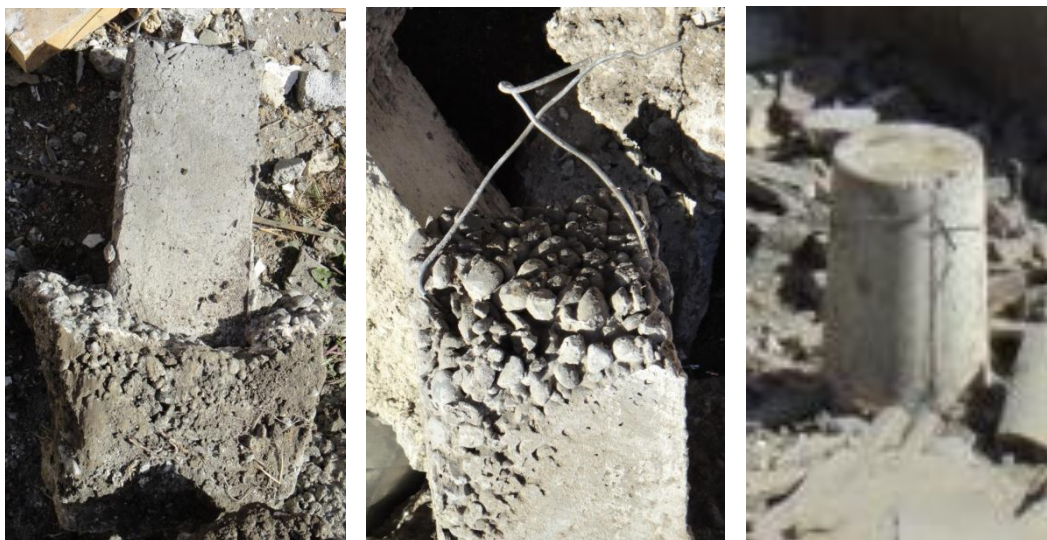
The main part of the foundation had 150-170mm square, cast-in-place piers ~350mm high above the ground. Their footings were ~300-350mm square and ~200-250mm deep. As for the perimeter, the aggregate was quite good, with a good mix of round and angular stones of varying sizes. However the concrete was much too dry, with number of piers having significant areas at the top with no mix around the aggregate (Figure 8).

Figure 8. Pier details, (left) square cast-in-place pier, (centre) close-up of dry concrete, (right) round pre-cast piers.

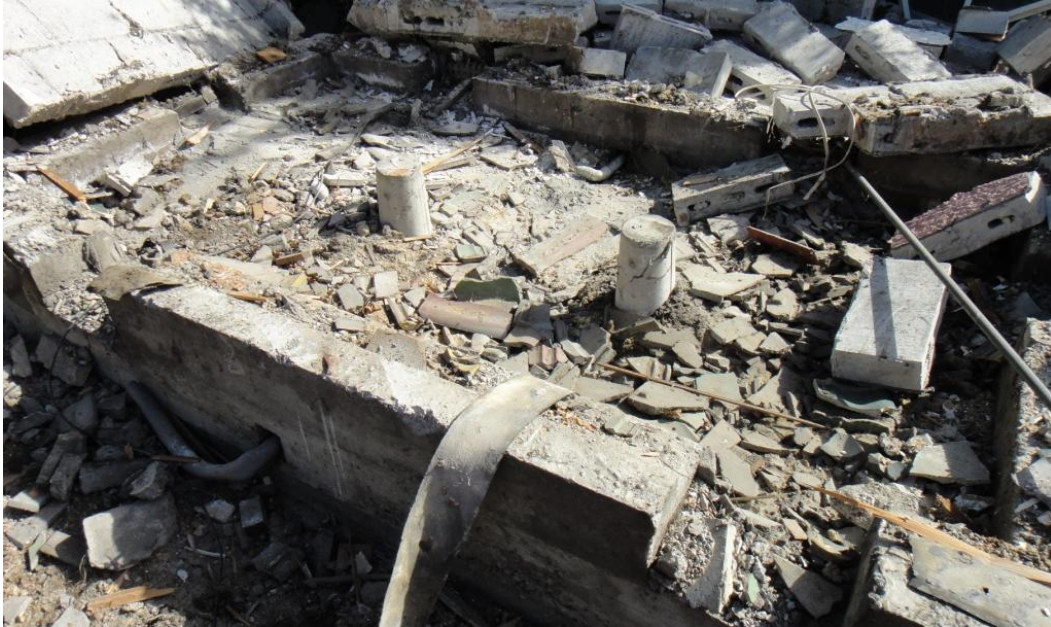
The only sand ejecta under the foundation was found under the West extension. Here the sand was very thick, 2/3 filling the extension at up to ~250mm deep. This extension was under the kitchen, so a high concentration of piping in this area may have led to the severely localised ejecta (Figure 9).

Figure 9. P4: Extension under kitchen, showing large volumes of sand ejecta.

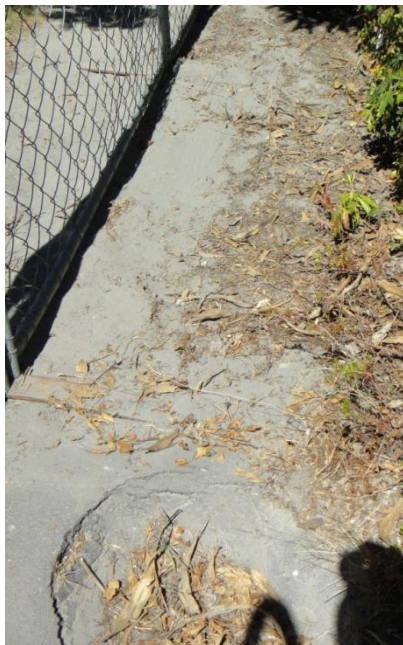
P5

There were signs of liquefaction ejecta still present on the property, along the front boundary in the footpath, and up to 100-150mm thick in the garage. However there was not a lot on the lawn itself (Figure 11).

Figure 11. P5: Sand ejecta in footpath at front. P6: Sand ejecta inside garage.

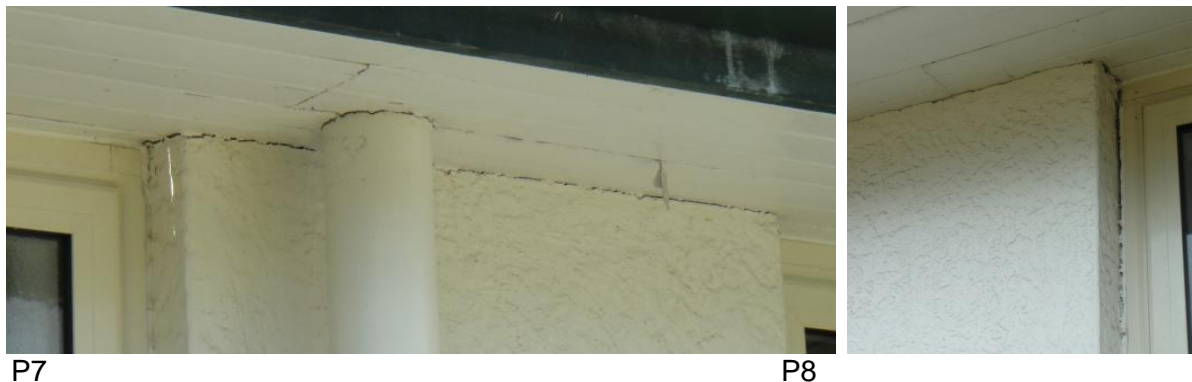
The main part of the house (North section) suffered low to moderate damage. On the West and North sides there were sections where the wall and underside of the roof were separated by 1-5mm (Figure 12). On the East side there were two cases of horizontal separation between walls and a window and the front door by 1-5mm. There were also minor vertical cracks in the stucco all the way around from 0-5mm. The interior of this section also suffered minor damage, such as hairline-1mm cracks in the plaster above window and door corners with one hairline crack in the ceiling of the bathroom, with a small crack in the tiling underneath (Figure 13). In this section of the house the doors were moving ok.

Figure 12. Minor exterior damage, separation between wall/roof (P7) and wall/window (P8).

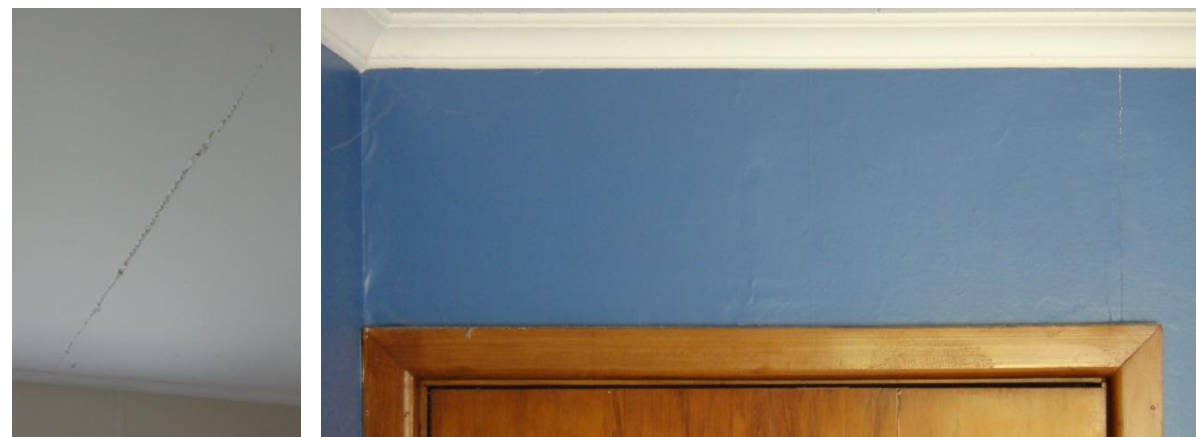
P9 P10
Figure 13. Minor interior damage: Joint crack in ceiling (P9) and cracking above door in plaster (P10).

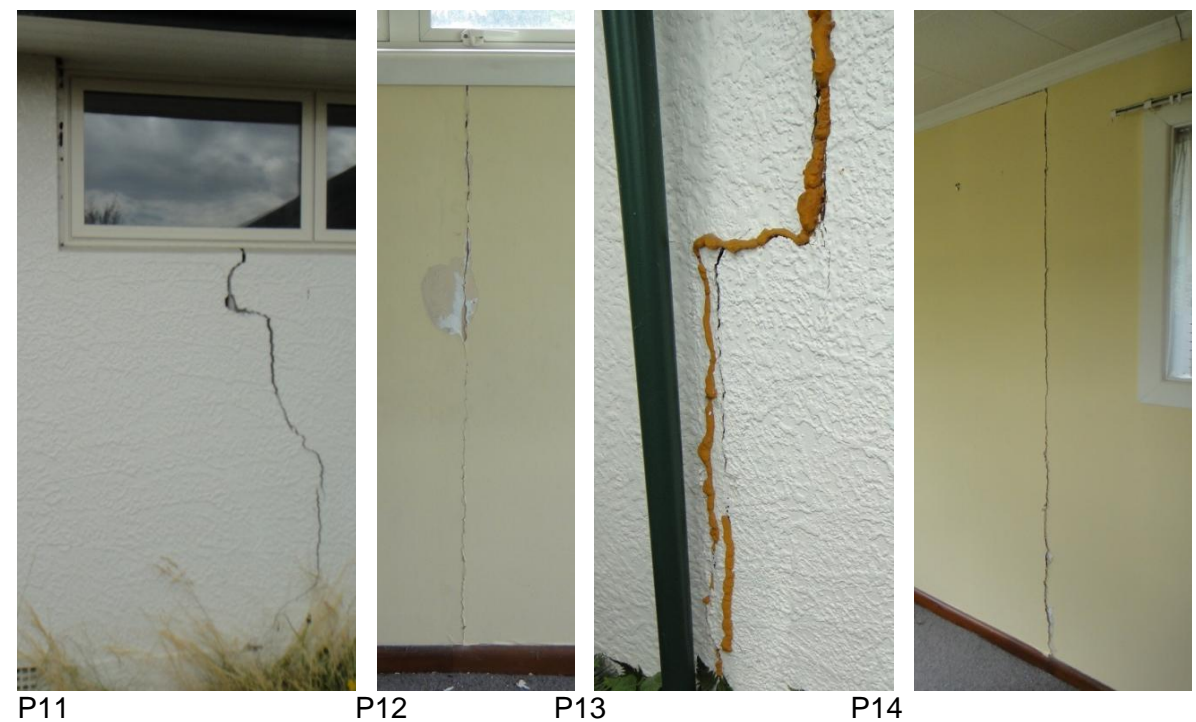
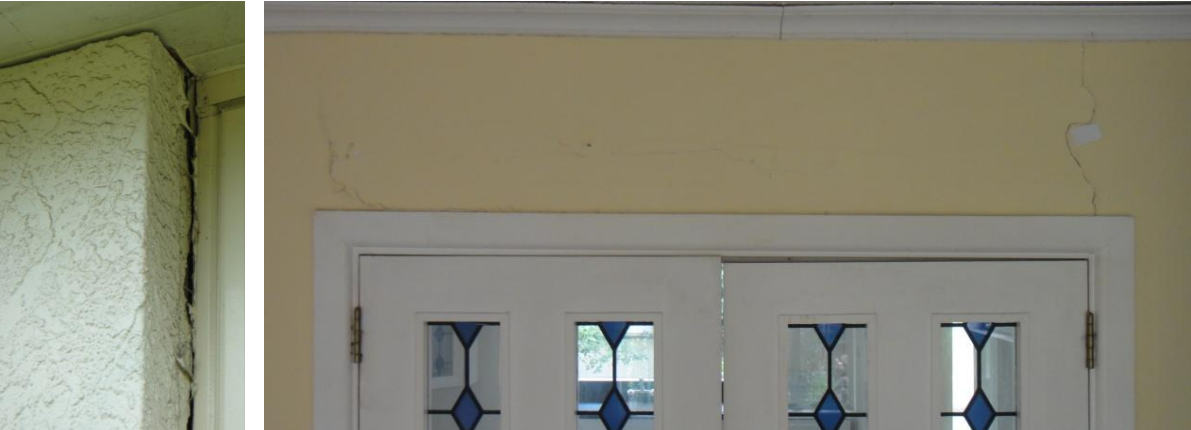
The worst damaged part of the house was the South and East section. On both the North and South walls of the Southeast room of the house, there were large matching structural cracks running through the stucco, and showing separation between the concrete blocks beneath. On the North wall, the crack was 2mm wide at the bottom, and cracked to 20mm width beneath the high window. From there it was translated to a separation between the window and wall of 20-30mm to the top of the wall (Figure 14, P11 and P12). On the South wall there were two cracks which opened up from 0mm at the bottom to 10mm at the top right beside each other. It is assumed these occurred in subsequent earthquakes as one was filled (Figure 14, P13 and P14). On the East wall of this section, at both North and South corners, there are cracks running up the wall and along beside the window from 1mm at the base to 5mm at the top as the walls either side of the window push out. Inside this room, the external cracks were matched by significant vertical cracks in the plasterboard at joints. There was also some racking offset between sections of plasterboard. In this South section of the house there were two door frames that were badly racked, preventing the doors from being closed (Figure 14).

P15 P16
Figure 14. High structural damage: Two matching exterior (P11, P13) and interior cracks (P12, P14). P15: High separation between wall and window. P16: Racking of door frame.

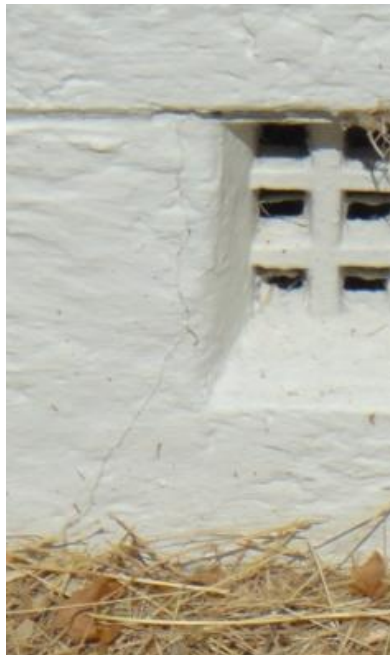
Eight hairline-1mm cracks were found around the concrete perimeter, which is a small number (Figure 15). The one 2mm crack identified was below the large structural crack going the height of the wall on the North wall of the Southeast room. This suggests that the perimeter was constructed well (good aggregate and reinforcing in the bottom), despite being a little dry in places.

Figure 15. P17: Hairline crack in perimeter.
